**Second  
International Conference  
on  
Case Histories in  
Geotechnical Engineering**

**June 1-5, 1988**

**University of Missouri-Rolla  
Rolla, Missouri**

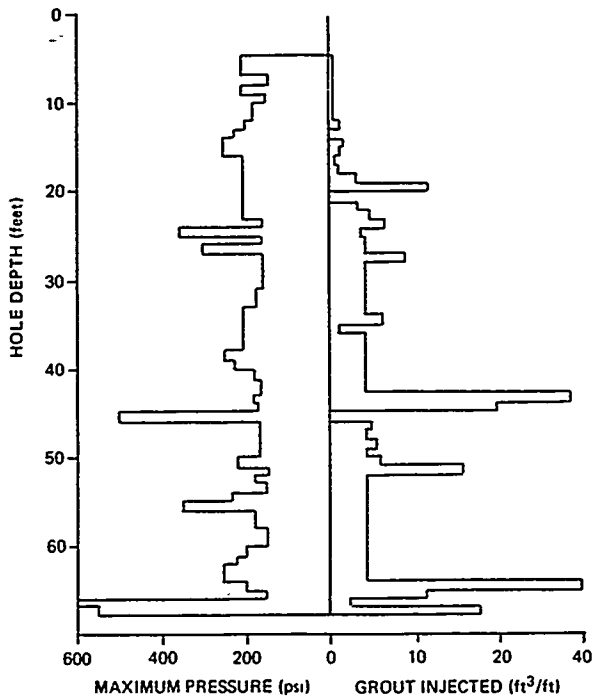
Figure 2. Injection Pressure - Volume Relationship for Typical Hole

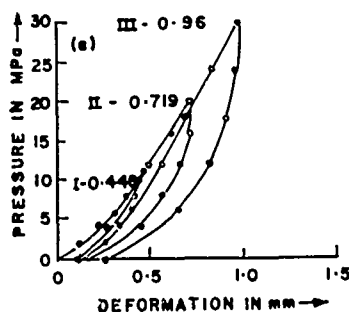
Fig. 2 Load Deformation Characteristic in a Typical Goodman Jack Test in HRT-1, ch.223.07 m, phyllites

Deformation modulus has been determined by both direct tests and by the rock mass classification approach. For direct tests, plate jack and Goodman jacks are commonly employed. Plate jacking test has been used to determine the deformation modulus in exploratory drifts. This technique has been found to be inferior in relation to the Goodman jack test method. The latter has therefore been used recently to determine the deformation modulus values from tests conducted in the tunnels. The tests were conducted in the NX size bore holes. The pressure was applied in cycles of 100, 200, 250, 500 and 700 kg/cm<sup>2</sup>. Pressures-deformation characteristics are given in figure 2.

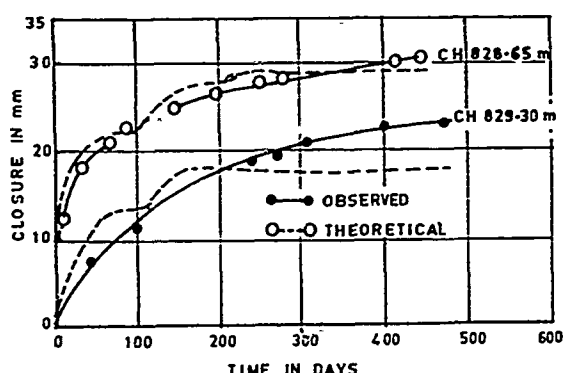
Fig. 3 Closure-Time Relation in HRT-3 (Grade III phyllites)

In the right bank diversion tunnel T-4, one test-section was established between chainages 614.50 m and 615.30 m with mechanical type of load cells. In the left bank diversion tunnel T-1, one test-section at ch. 083-84 m was established. Mechanical type load cells were installed. In the head race tunnel T-3, one test-section was installed at ch. 828-829 m. Vibrating wire and mechanical type load cells were installed. Typical closure-time and load-time graphs are shown in figures 3 to 4 respectively for this test-section. The theoretical values are also shown in these figures.

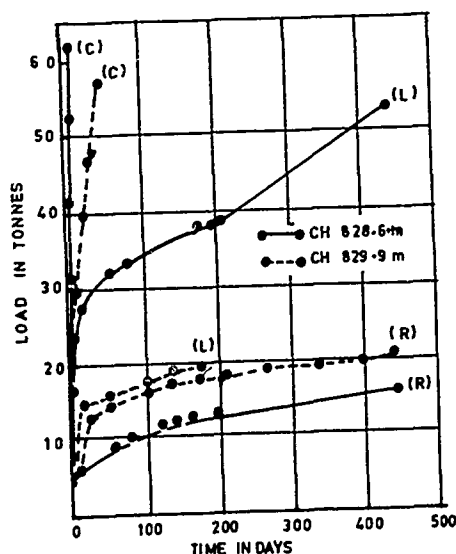
Fig. 4 Load-Time Relation in HRT-3 (Grade - III phyllites)

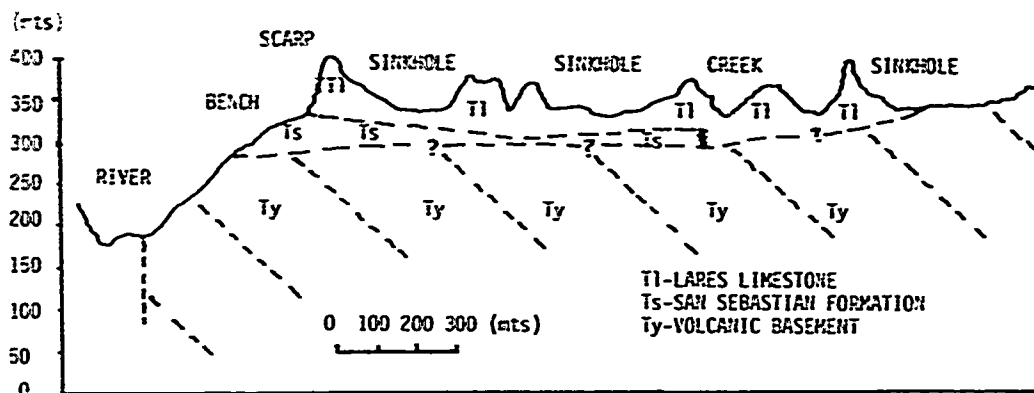
Fig. 1 Schematic Cross Section in a North-South Direction

below, and on the immediate north by the steep rock escarpment (cuesta scarp) of the Lares limestone plateau which extends another 150 to 300 ft. higher (Figure 1). This position places the route alignment right along a precarious condition of a plateau margin (Deere et al. 1987), as shown in Fig. 1.

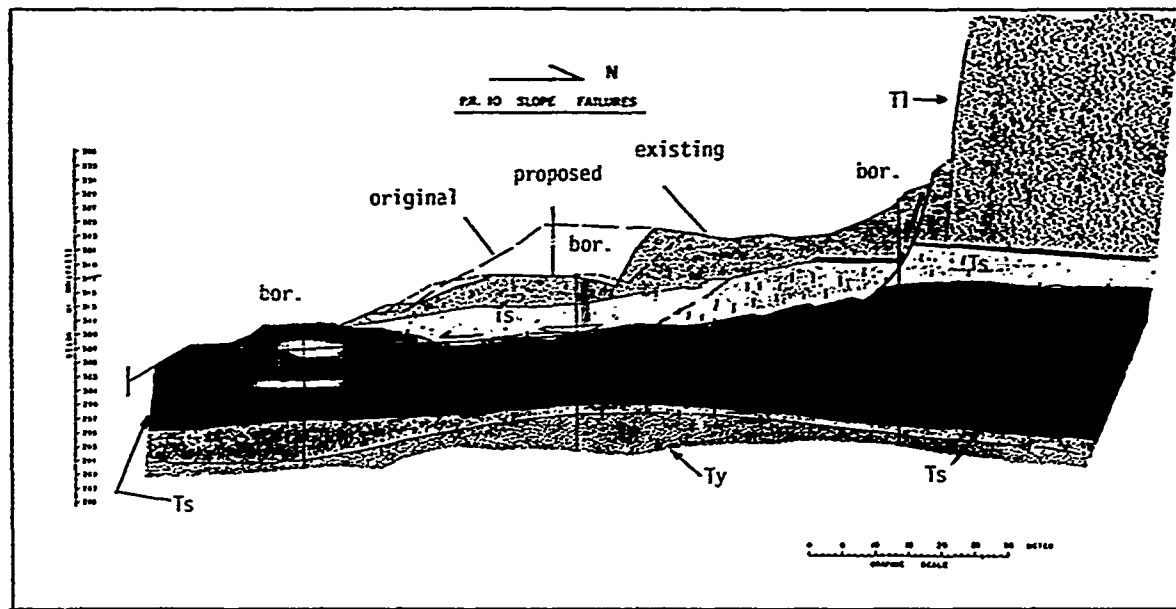
Fig. 2 Soil Profile and Slide Surface at Station 192+10

For most of its alignment, the road sector is underlain by landslide deposits (Q1), a muddy limestone unit of the Lares Limestone Formation (T1), hard overconsolidated clayey soils called the San Sebastian Formation (Ts), and a generalized volcanic rock basement (Ty, Ka). Figure 2 shows a typical profile in the failed road sector.

A detailed geotechnical evaluation was conducted. Several deep borings were drilled at and around the sliding mass. The resulting soil profiles were consistent with the anticipated sequence of geologic strata described before. Figure 2 shows a typical profile of the sliding road sector. For the borings located near the base of the limestone scarp, the upper soil samples could belong to the lower unit of the Lares limestone or to the colluvium accumulated down-slope.

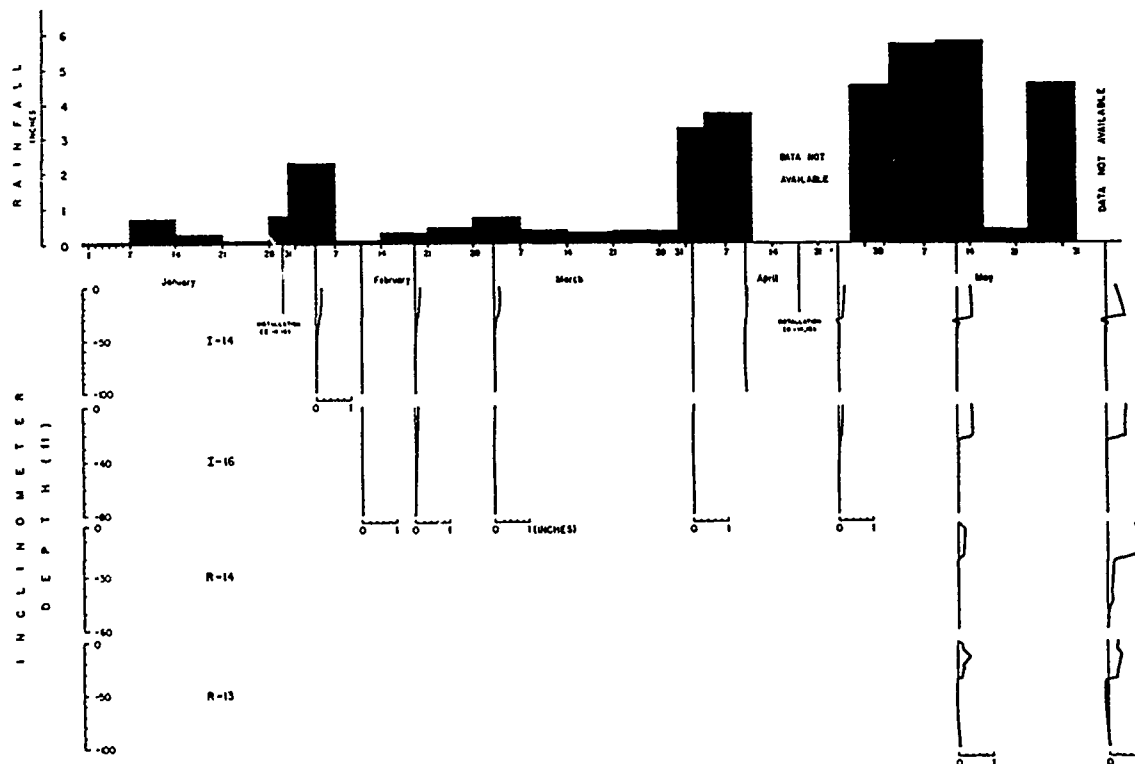
Fig. 5 Rainfall versus Displacements at Inclinometers

Ten piezometers and eight inclinometers were installed and monitored for a period of six months for determining groundwater levels and depths of active sliding surfaces. The inclinometers were installed during a relatively dry period where the movements measurements were small (Fig. 5). It is during the period of heavy rains that the rate of movement increased, reaching large displacements in excess of 1 inch where shearing off of some of the inclinometers casings developed (Fig. 5).

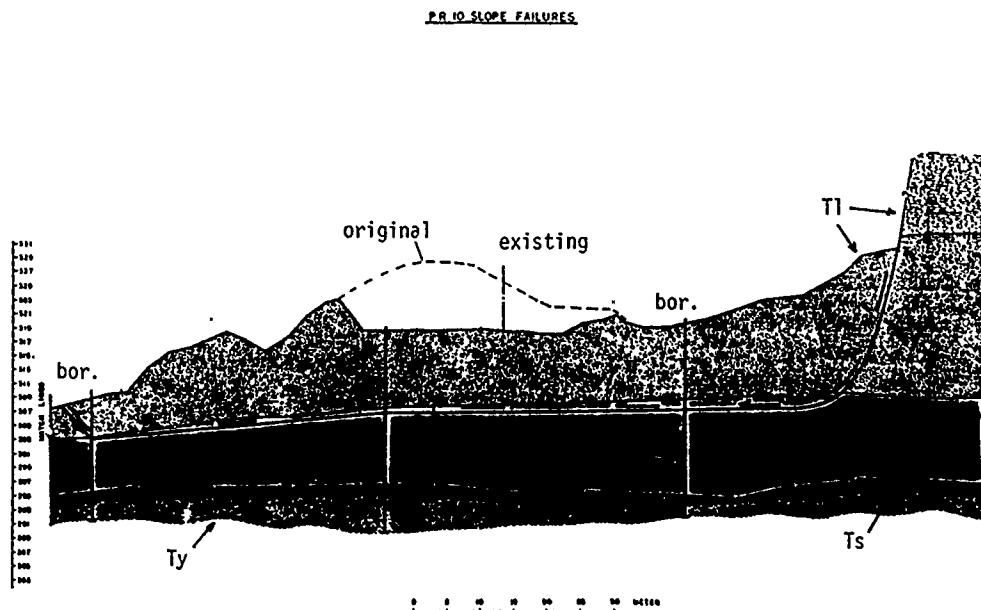
Fig. 6 Soil Profile and Slide Surface at Station 193+65

The depth and shape of the sliding surface was determined with the inclinometer data and the field characteristics of the moving mass. The sliding surface starts at the head scarp and follows the contact between the organic and "typical" layers of the San Sebastian formation. The depth of the sliding surface as determined by the off-sets in the inclinometers was about 40 ft. The sliding mass included the base of the muddy limestone, the colluvium and the underlying overconsolidated clays. The sliding mass has a volume of about 0.6 million cubic yards. Figures 2 and 6 show two profiles indicating the position of the sliding surface and the observed groundwater levels.

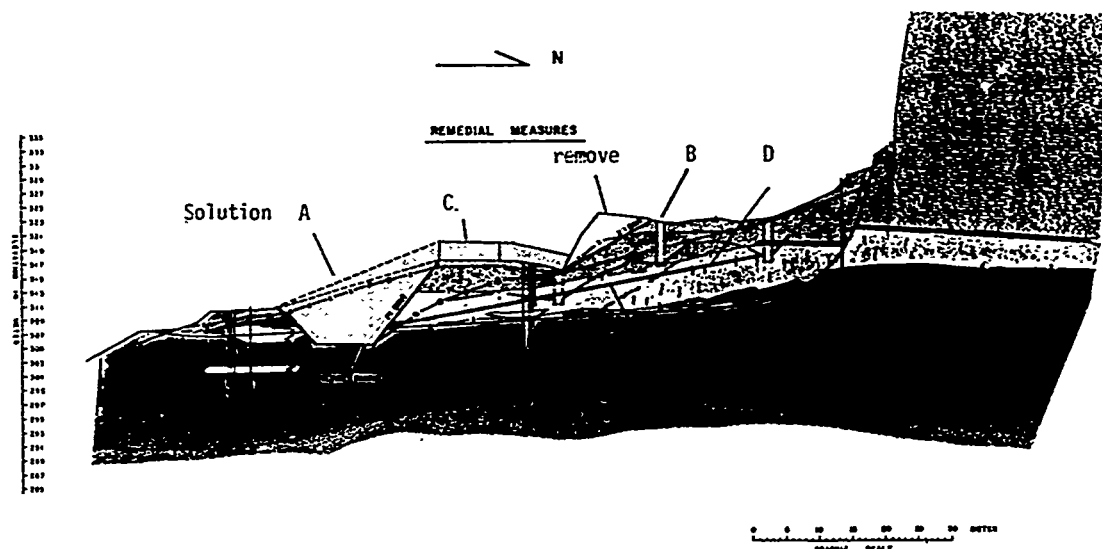
Fig. 7 Remedial Measures for Landslide at Station 191 to 195

The recommended solution alternatives involve several forms of subsurface drainage, improvement of the soil conditions at the slide toe area, and incorporation of a weighting berm (to increase the resisting forces and reduce the effect of the large cuts for grading operations). The following remedial alternatives have been proposed for this project (Fig. 7):

- a. Stabilizing drainage key
- b. Solution (a) with upslope drainage trenches
- c. Solution (b) with 8 ft. high berm
- d. Solution (c) with horizontal drains
- e. Drainage galley with horizontal drains
- f. Permanent wells with horizontal drains
- g. Combination of some of the above

The major stabilizing element will be the "stabilization drainage key", an excavated drainage ditch near the toe of the slide and to the downslope side of the new highway. The proposed key is up to 50 ft. deep, backfilled with gravel and with a filter fabric lining (Fig. 7). The key will extend a few meters below the determined sliding plane and will increase the factor of safety from 1.0 (rainy season potential condition) to about 1.4. Prior to building the key, it is required to lower the existing water level, considering the disturbed and fissured nature of the slide mass. Studies are presently being made of two procedures for lowering of the water level: (1) parallel small, drainage trenches or ditches (labeled B in Fig. 7) at two or three locations between the new highway and the scarp (excavated and backfilled in small lengths), or (2) 10 ft. to 13 ft. diameter drainage wells (or shaft) near the scarp with horizontal drain holes drilled from the shaft at all wet zones. Also, borings are presently being made in the karstic northern limestone to evaluate the possibility of partially draining the sinkhole system to reduce the feeding of water to the lower colluvium and the San Sebastian formation.

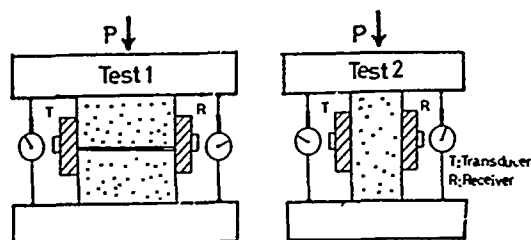
Fig. 4 Schematic Diagram For Test Procedure

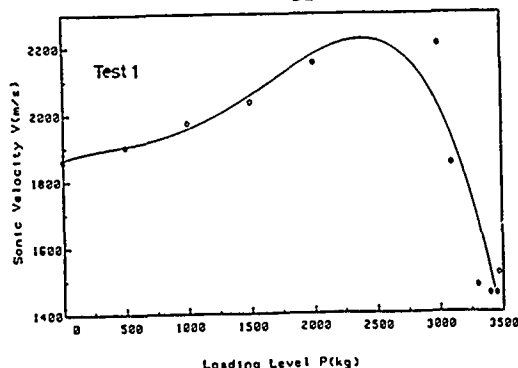
Fig. (5a) Variation of loading level with sonic velocity

It appears from Figure 5. that the longitudinal pulse wave transit through the sample was increased by 16 % in test 1 when the load have increased from 0 to 3000 kgs, and by 6.4 % in test 2 when the load increases from 0 to 1500 kgs. This fact was mentioned in the pioneer work of wyllie et al. (1958) and confirmed by Warren (1973) as well as by the recent work of Masayasu (1981) on his study concerning the relation of uniaxial compressive strength and elastic waves for soft rock. In other hand he concluded that this relation is rather very poor. However, the velocity increases at high pressure which is followed by increases in  $C_b$ ,  $E_s$  and  $E_d$  too, may results from changes in intrinsic properties of the rock such as the compaction and the reduction of the pore space caused by the contact occurs between Particles during loading. Thus the rapid increases of velocity at low pressure may be attributed to these effects. It was suggested that velocity

may reduces sharply just before the maximum bearing capacity reached. In one way or another this fact looks to agree with results obtained in Figure 5. It can be traced from results also that ratio  $E_d/E_s$  was decreased by increasing the normal pressure (Figure 6) from 4 at 500 kgs. to 2.5 at 3000 kgs. for test 1 and from 3.5 at 500 kgs. to 1.4 at 1500 kgs in test 2. However this ratio was found to approach unity at higher level of loading. According to King (1969) the  $E_d/E_s$  ranging from 1 to 3 for most rock type. Although the compressibility ( $C_b$ ) results (Figure 7) were almost identical for test 1 and test 2, but it does show the effect of heterogeneity, plane of weakness on rock deformability when subjected to normal loading. Brace (1965) mentioned that linear compressibility on a number of rocks with preferred orientations dependent upon the orientation of grains and pressure and is different in different direction. Fattohi, 1986 a, found out that the particle reorientations and

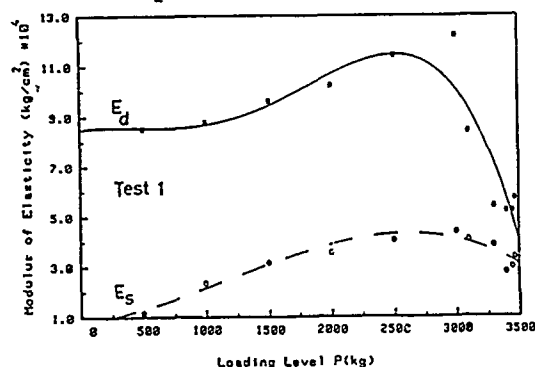
Fig. (5b) Variation of loading level with sonic velocity

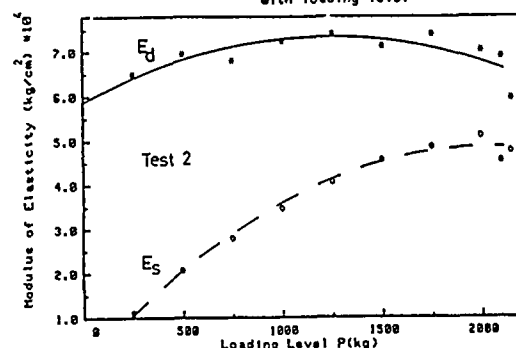
Fig. (6a) Changes of static and dynamic moduli values with loading level

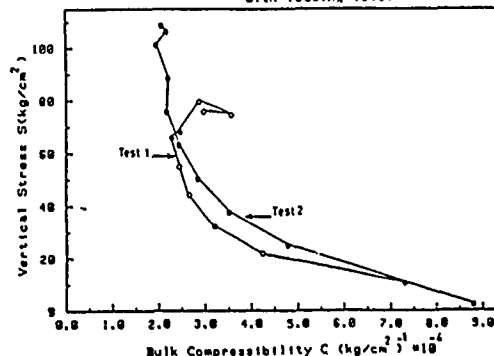
Fig. (6b) Changes of static and dynamic moduli values with loading level

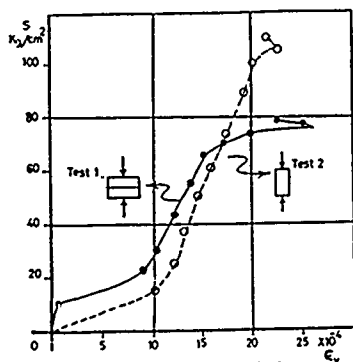
Fig. 8 Stress-Strain Relation

displacement, which may take place during compaction have changed the bulk compressibility of soft sandstone. Lama and Vitukuri (1978) have also confirmed the effects of grain, pores and cracks on such rock property. For a more clear picture of these effects, Figure 8, is a plot of vertical strain ( $\epsilon_v$ ) and stress. It is clear that ( $\epsilon_v$ ) for test 2 is more linear and having a brittle form than the curve for test 1 because of the initial fracture occurrence.

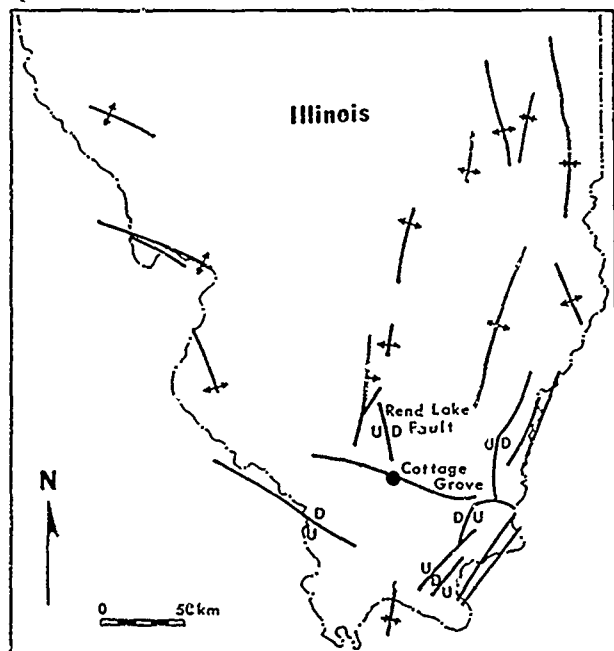
Figure 2. Structural features of southern Illinois.

The most important structural feature in the vicinity of the site is the Cottage Grove Fault System (Figure 2) which interrupts the slight regional dip to the north, trends WNW-ESE and has been characterized as a right-lateral strike-slip fault with a displacement of less than one mile (Nelson and Krausse, 1981). Numerous minor faults are associated with the system; most are normal, but reverse and oblique-slip faults have been described. Vertical displacements of up to 200 feet (60 metres) are associated with these minor faults. Subsidiary anticlines with limbs dipping up to 15 degrees have been reported in association with the Cottage Grove Fault

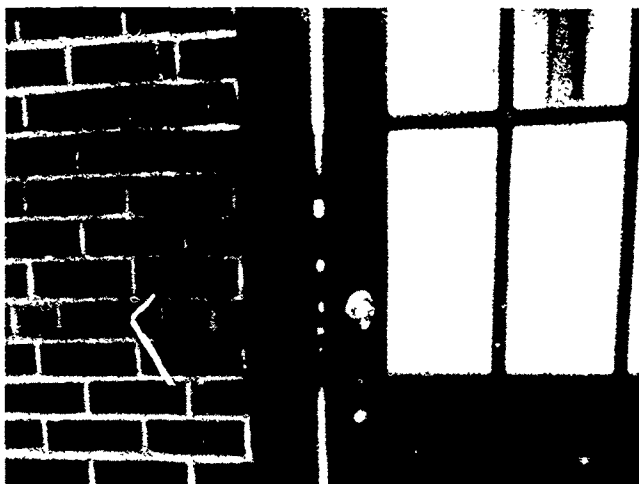
Figure 4. Misaligned door frames.

The initial subsidence damage to Johnston City's Washington Elementary School was first observed during the Christmas school holidays. Janitors working during this break discovered cracks in the walls and ceilings of eight school rooms (Figure 3). Door frames were misaligned (Figure 4) and large fractures were visible on outside foundations, sidewalks, and school playgrounds (Figure 5). Damage was so extensive that the building was declared unsafe and was demolished shortly thereafter.

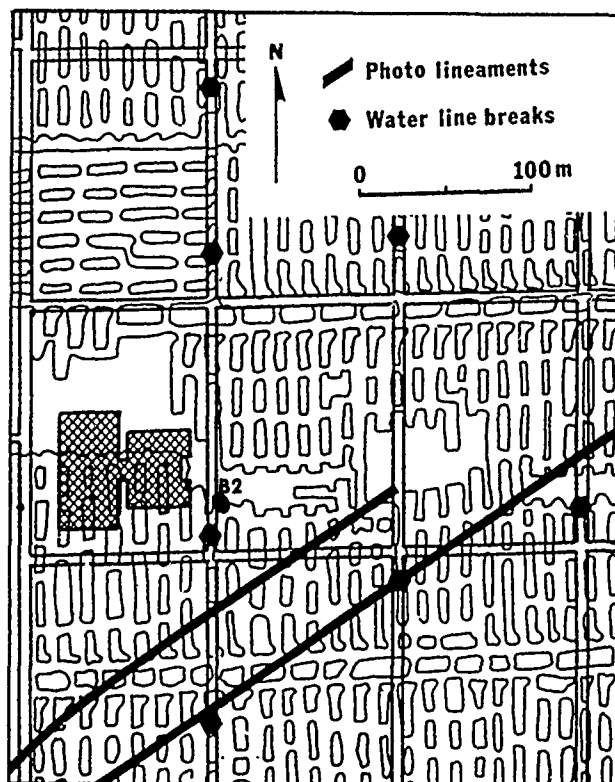
Figure 6 Mine layout and indications of subsidence.

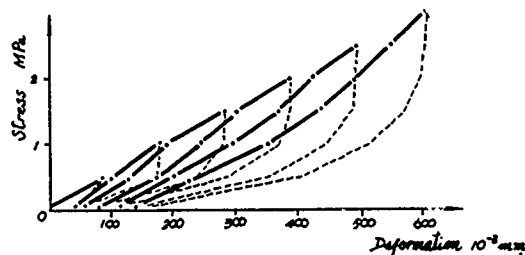
Fig. 2 Stress-deformation curves for rockmass

The static modulus of elasticity was measured in an adit with a jack and typical stress-deformation curves for loading-unloading cycles are shown in Fig. 2.

Test results showed that for the silicarenite and striped sandstone, every loading-unloading cycle caused an obvious incremental residual deformation. The modulus of elasticity was calculated for each loading-unloading cycle. It was found that the higher the loading stress, the smaller the value of  $E$  was, and that the modulus of deformation was much lower than the modulus of elasticity for the same loading level. To the maximum, they may differ by a factor of 3. This was more conspicuous in the horizontal than in the vertical direction. The values of  $E$  in the horizontal direction were mostly greater than those in the vertical, and the degree of anisotropy decreased with increasing stress. The anisotropy of the rockmass was mainly brought about by the effects of the occurrence of various discontinuities, the state of fractured zones and the properties of fill-in materials.

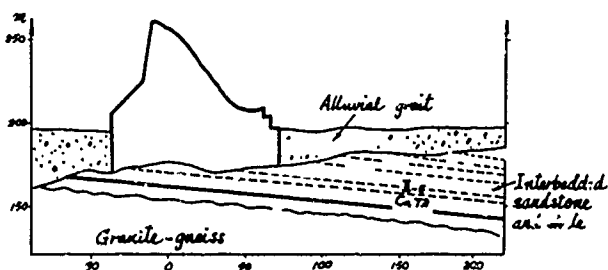
Fig. 1 Rock formation of the dam site.

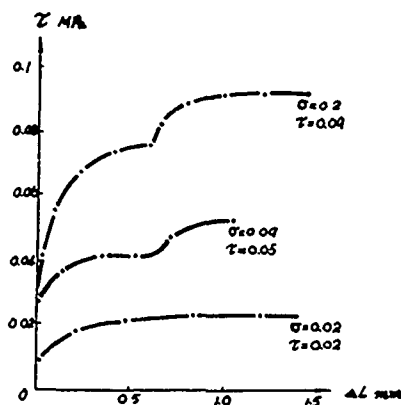
Fig. 3 Typical stress-displacement curves for clayey intercalation NO. II-5.

Typical stress-deformation curves for the clayey intercalation II-5 are shown in Fig. 3. It was found from the test result that the clayey intercalation was characterized by large deformation and low strength. Its shear strength depended on the roughness of the interface and the thickness of intercalation. Four different cases were identified. First, when the interface was smooth and the intercalation thickness was greater than the interface fluctuation, the shear strength was very low since shear fracture took place along the weak interface between the rock and intercalation. Second, when the intercalation thickness was smaller than the interface fluctuation, the shear strength was controlled by the interlocking between the rock surfaces and had a higher value. Third, when the intercalation was locally lacking, the shear strength was increased significantly by the friction between rock surfaces. Finally, when the rock had a zigzag surface, a portion of it was sheared off and thus the shear strength was greatly increased.

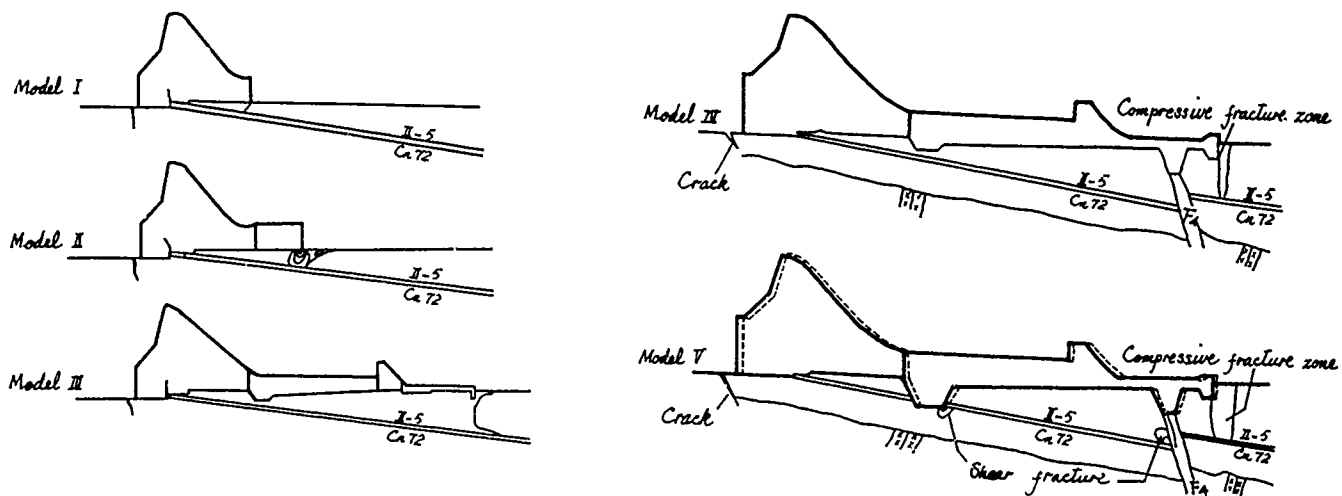
Fig. 5 The mechanism of failure of test models

Five models were made. They were (see Fig. 5): Model I: in the foundation of the dam type originally designed before finding II-5 and Cn72, cut-off passing through these two intercalations was excavated in front of the dam; Model II: the same as model I except that the dam back was thickened; Model III: underflow-overflow scheme; Model IV: developed from model III with fault  $F_4$  stabilized by fault plugs and shallow cut-off excavated at the heading part of the apron; Model V: it differed from model IV in that a deep cut-off cutting out the two intercalations was excavated at the heading part of the apron.

The modes of failure of models IV and V are shown in Fig. 5. In model V, obvious overall movement of the host rock between the middle cut-off and fault  $F_4$  was observed

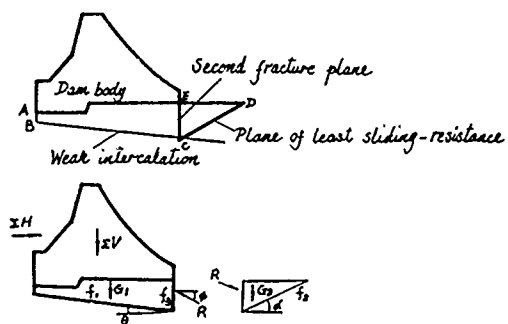
Fig. 4 The force system for limit equilibrium calculation

The weak intercalation dipping downstream was assumed as a sliding plane (BE) when using the theory of limiting equilibrium to analyze the stability against sliding in design. It was also assumed that there was a vertical shear fracture plane CE (Fig. 4) in the dam site. Since the most developed fracture perpendicular to the river bed in the dam site has a high dip angle of  $80^\circ$ , this assumption seems to be a reasonable approximation of the reality. By assuming that the rockmass behind the dam fractures along plane CD when the sliding plane has

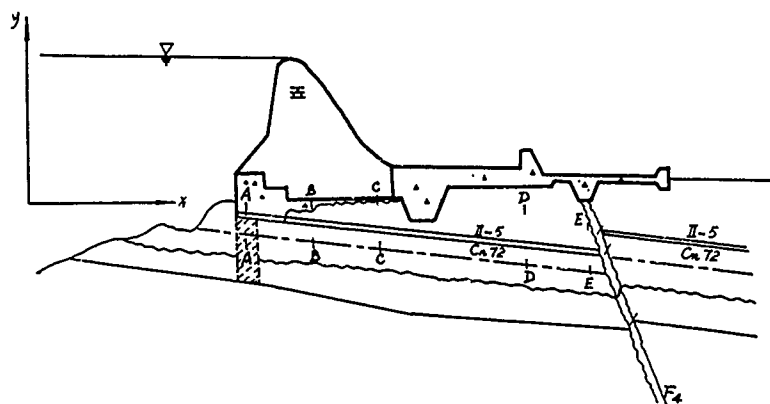
Fig. 7 A schematic diagram showing the sections for computation

In computation, 11 materials of different properties were used and some 900 elements were divided (Fig. 7) which were the main part of the computed region. It was known from the result of computation that horizontal tensile stress occurred in most elements within in the dam heel zone. Owing to the low tensile strength of the rockmass, cracks with high dip angles developed especially in the dam foundation. Therefore, in the first adjustment, cracking along a certain interface between elements was assumed (cracking along a vertical interface at the dam heel was assumed in actual computation). Along that interface, original nodes were replaced by twin-nodes while the interface was considered as a free boundary.

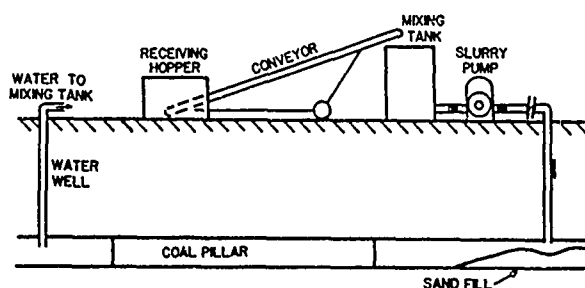
Fig. 1 Slurry Pumping System (Colaizzi et.al., 1985).

The method used to backfill the mine voids in the Rock Springs Subsidence Control Project was the pumped-slurry method of hydraulic backfilling (Colaizzi and Bithell, 1986; Colaizzi, et.al., 1981). In this process, a homogeneous mixture (slurry) of water and granular material is pumped from a remote plant site to the injection hole. The free falling slurry moves through a vertical steel casing to be deposited in subsurface voids (Fig. 1).

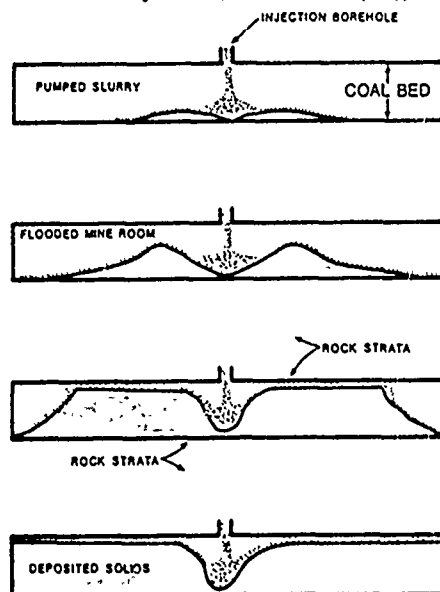
Fig. 2 Section View of Slurry Deposition (Colaizzi and Bithell, 1986).

The degree of void filling is a function of the velocity of the slurry flow at the mine level. As the slurry first enters the mine void from the injection borehole, its velocity is greatly reduced due to the increased cross sectional area of the transporting conduct (Fig. 2). This

rapid drop in velocity causes the solid particles to be deposited to form a doughnut-shaped mound on the mine floor. As the height of the mound approaches the mine roof, the velocity of the slurry increases through the narrowing channels, and the solid particles are transported to the outer limits of the mound. At the boundary of the mound, the velocity decreases abruptly and the solids are deposited on the advancing face of the pile. The process continues until the energy required to maintain the flow of the suspended particles becomes greater than the energy supplied by the available gravity head.

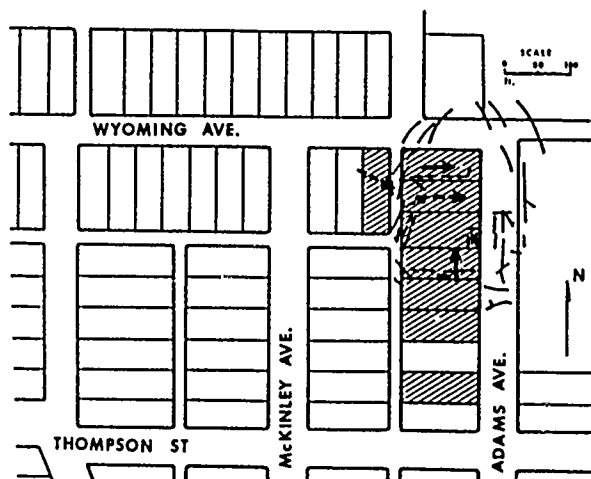
Fig. 3 Surface Damage Adams Avenue Area.

The extent of surface damage was assessed. Crack movements were monitored and measured. Surface ground cracks were surveyed and mapped (Fig. 3). Rotary and core drilling was performed around the affected area and the residences reporting damage. Boreholes were inspected with a video camera. Soil and rock samples from coring were tested.

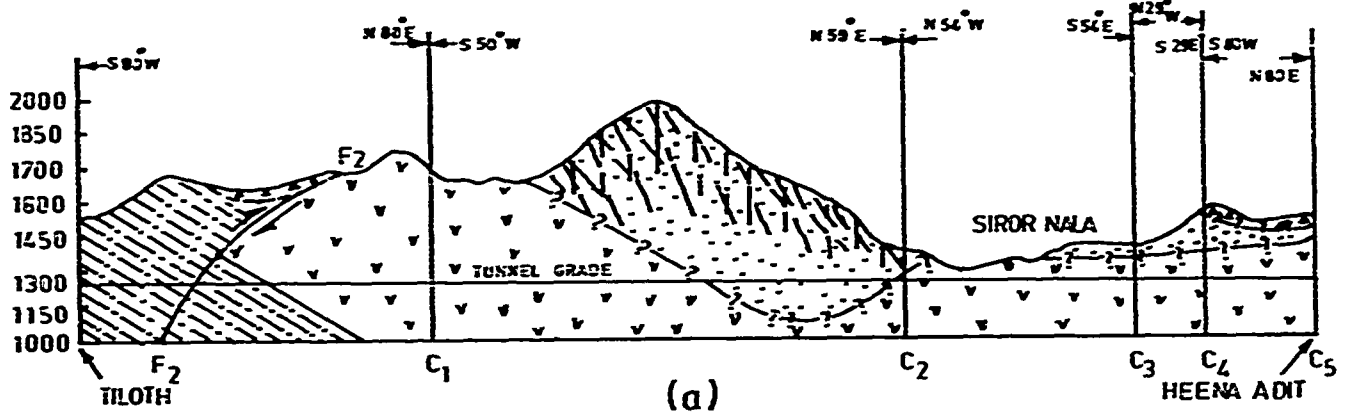
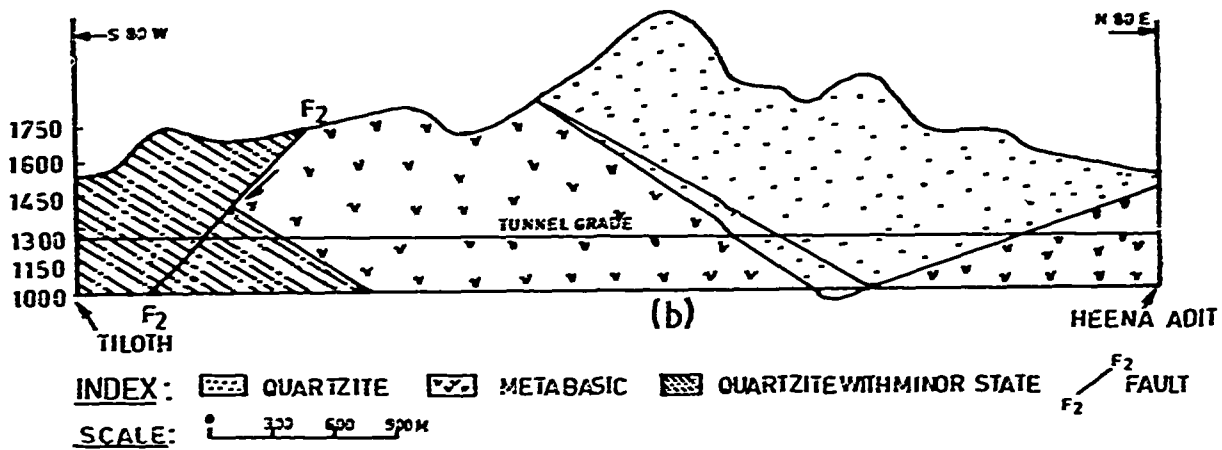
Fig.1 Geological Sections Between Heena and Tiloth along (a) Alternative Alignment No.2 and (b) The Straight Tunnel Alignment (after Jain et al, 1976)

The longitudinal geological cross-section along the original straight alignment and along the alternative alignment No.2 between Heena and

Tiloth has been shown in Fig.1, while the longitudinal section along the final alignment has been shown in Fig.2.

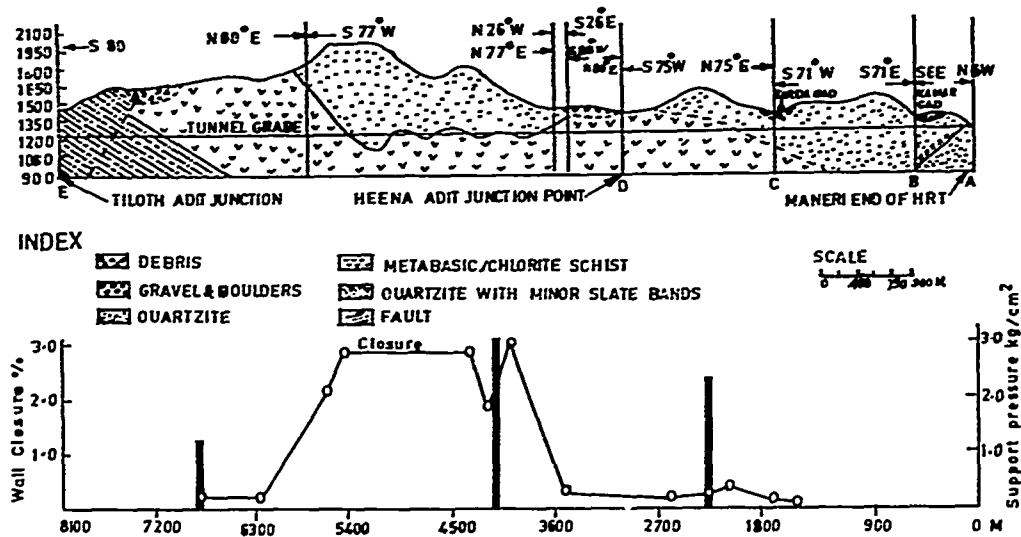
Fig.2 Longitudinal Geological Cross-Section Along the Power Tunnel (after G.S.I.)

The tunnel passes through basic-metabasic-chlorite-schist type of rocks upto ch 3530 m. Beyond this place the tunnel passed through jointed and blocky quartzites folded in a synclinal form Fig.2. The quartzites occurring in the core of the syncline were bounded by relatively impervious metabasic chlorite-schist formations on both the sides. The quartzites occurring in the syncline were, thus, heavily charged with water, the water head being 80 m. Two cross shear zones of about 40 cm width were intersecting close to the crown of the tunnel (Fig.3). The presence of these two shear zones, their intersections at the tunnel grade and the presence of a water reservoir inside the hill triggered the collapse of the tunnel face and the sliding of a huge quantity of muck with heavy inrush of water. The washings of the drill holes indicated that the material in the shear zones was not groutable with ordinary portland cement.

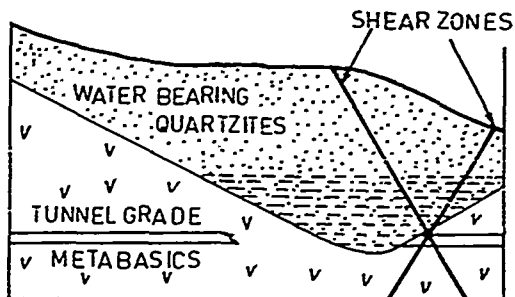
Fig.3 Detailed Sketch Showing the Causes of Water Inrush

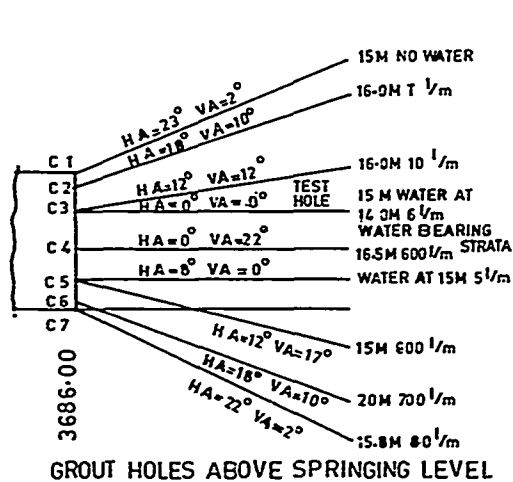
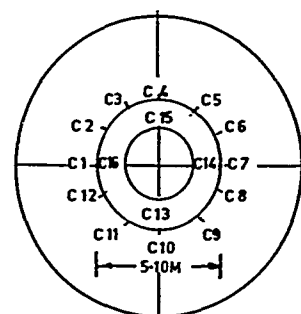
Fig.4 Plan at EL 1266 m Showing the Details of Exploration Work

POSITION OF WASON DRILL HOLES

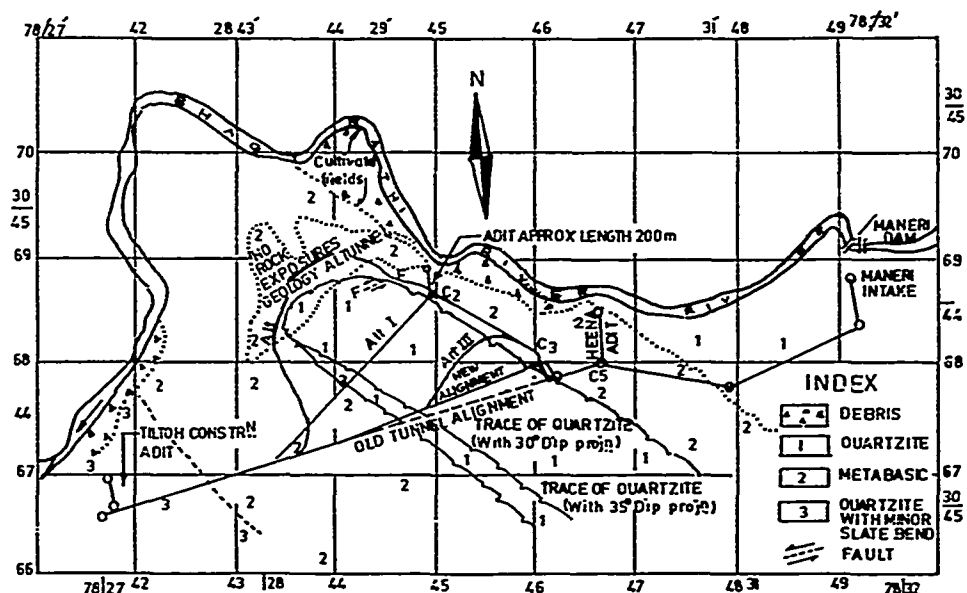
Fig.6 Plan at EL 1250 m Between Maneri and Tiloth Showing Alternative Tunnel Alignments

Three alternate alignments (as shown in Fig.6) for diverting the tunnel towards the right side were proposed with the objective of maximising the rate of tunnelling through a safe and better tunnelling media, i.e. through the meta-basic formations. The length of the tunnel in the process increased by 0.47 to 1.85 km but the tunnel length through the highly water charged and fractured quartzites could be reduced by about 280 to 680 m in the case of alternatives I & III and completely avoided in alternative II.

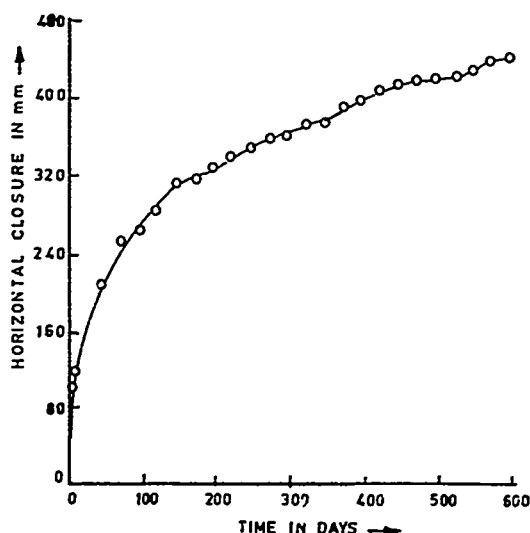
Fig.8 Closure-Time Relation at ch.4180 m

The data analysis shows that the maximum closure was of the order of 430 mm (8.9 percent) in 600 days at the synclinal contact of metabasics and quartzites at ch. 4180 m (Fig.8). At other locations, the closure varies from 10 mm to 20 mm (0.2 to 0.4 percent) except at ch. 5510 m, where the total closure observed in 100 days was about 105 mm (2.18 percent) at a depth of 750 m (Fig 9). It is clear from Fig.9 that the wall closure increased in stages. This is due to the buckling of the steel ribs. Support pressure estimated from the load-cell data varies from  $1.22 \text{ kg/cm}^2$  at ch.6760 to  $3.05 \text{ kg/cm}^2$  at ch.4140 m (please see Fig.2).

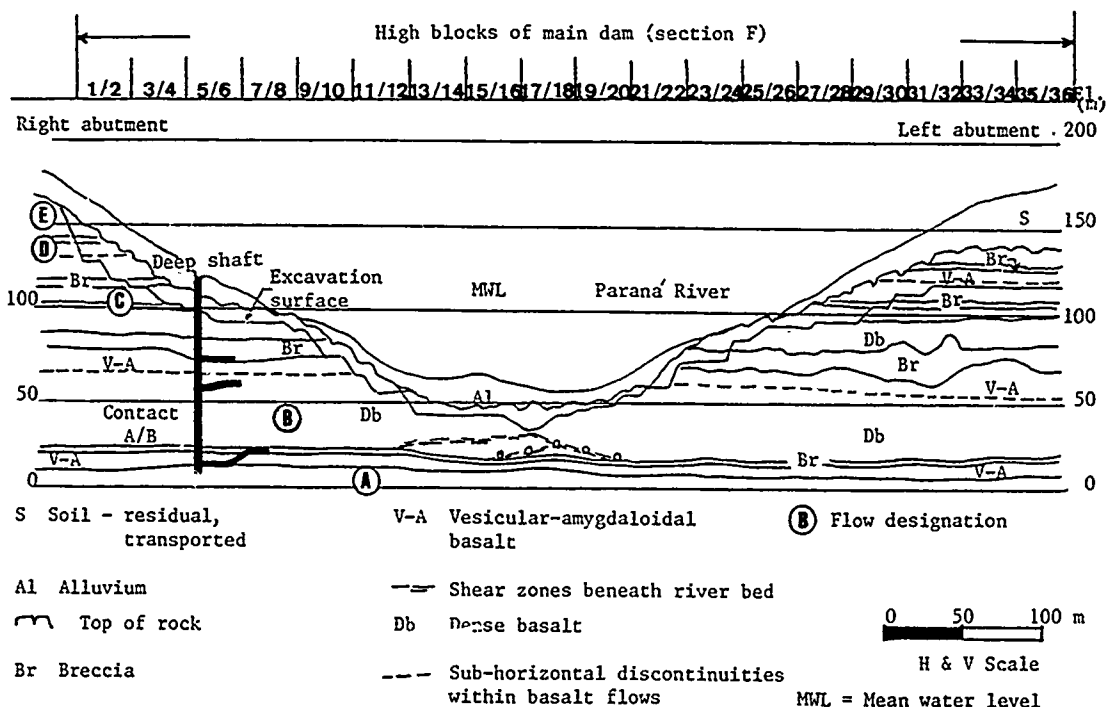
Fig. 4 Itaipu Dam Site. Geologic Section across the River Valley.

Investigations of the foundation area for the high dam within the deep channel carved by the Parana River began with some preliminary conventional borings in the banks, abutments and on the shallow Itaipu Island itself. The first stage of the studies called for only a few borings and seismic refraction traverses to define rock types at several alternative dam axes. Five basalt flows with interflows of sedimentary breccia were identified during this stage and named, from the bottom up, flows A through E (Fig. 4).

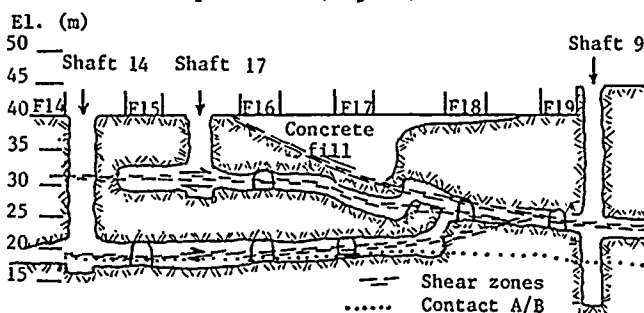
Fig. 5 Section along Axis of Main Itaipu Dam Showing Principal Shear Zones below Foundation Level Followed and Intercepted by Tunnels.

flow B in the river channel. While various solutions were being sought, an accelerated program of borings was initiated to determine the distribution and extent of the shear zones. In addition, it was decided to follow those zones, to permit direct observations and more accurate appraisal of the geomechanical parameters by tunneling parallel and perpendicular to the dam axis whenever possible (Fig. 5).

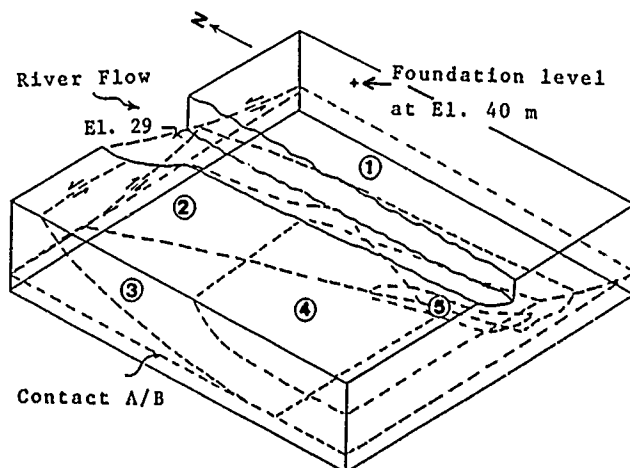
Fig. 6 Block Diagram Indicating Relative Locations of Shear Zones below River Channel.

The borings made from the foundation level and the exploratory tunnels eventually permitted a three dimensional visualization of the relationship among the shear zones within the foundation area for the high concrete dam. When the investigations were completed it was possible to differentiate the zones as follows (Fig. 6):

1. Eastward-dipping shear zone. This is the uppermost shear zone and the first to be exposed along the deepest portion of the river, following the stem of half block F-17. It intercepts the originally proposed foundation level of El. 40 m at the head of half-block F-15, dips  $15^\circ - 20^\circ$  E-SE and varies from very weathered, with a filling consisting mostly of clay at higher elevations, to almost a rock to rock contact of lamellar slabs at the lower levels, close to the contact between flows A and B. Slickensides on the surface of this zone indicated that the rock mass above it was thrust westward, towards Paraguay.

2. Westward-dipping zone. This zone is tangential to contact A/B on the west side of the river channel, as seen in the deep, right bank shaft and the tunnel at El. 20 m. It rises at a low angle until it is intercepted by the eastward-dipping zone. Shear displacements could not be observed on the west side, probably because of a high degree of weathering and considerable clay. Eastward updip displacements of as much as 30 cm were measured.

4. Downstream southward-dipping zone. This zone, with an approximate area of only 40 m by 50 m, was found during the final phase of investigations of the foundation area. Core drilling in an area nearly 46 m south of shaft 17 had revealed another zone of lamellar fragments with a low clay content. As it progresses downstream from El. 35 m and El. 30 m to lower levels, it tends to narrow down and disappear, forming a fault slice imbricated upon the upstream south-dipping zone described above.

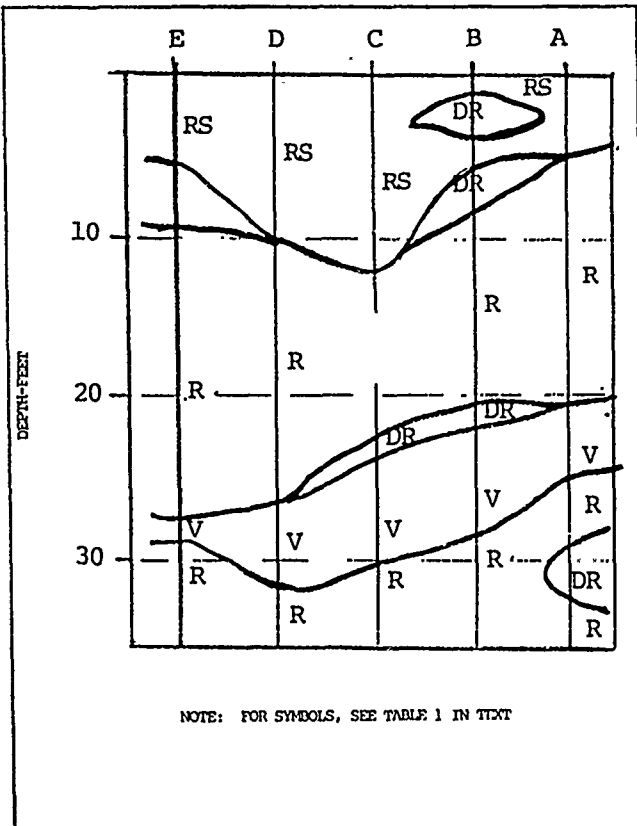
FIGURE 3 - SUBSURFACE STRATIGRAPHY AS INFERRED FROM PROBING

The percussion probes indicated that the overburden soils were relatively thin and that the bedrock contained a large, continuous cavity beneath the entire plan area of the proposed structure. A typical subsurface cross section depicting the subsurface stratigraphy before grouting, as inferred from probing, is shown in Figure 3. For these conditions, several foundation design alternatives were considered.

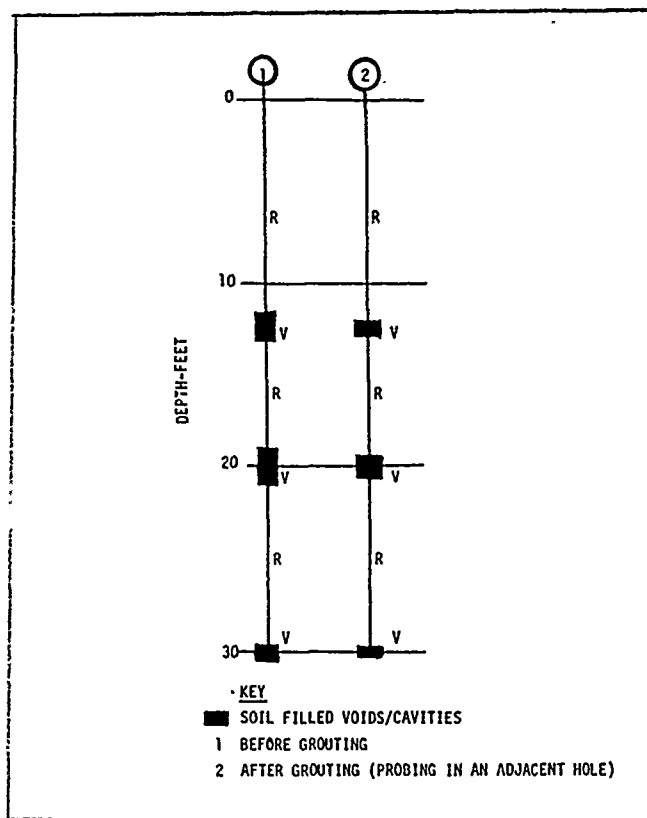
FIGURE 4 - ROCK MASS QUALITY BEFORE AND AFTER GROUTING

After grouting, probes were advanced adjacent to the grout holes to determine rock mass quality and the extent of any remaining cavities. A comparison of the results of probes showing the rock mass qualities and extent of cavities before and after grouting is presented in Figure 4. It can be seen from this comparison that there was only a slight improvement in rock quality due to grouting. This was attributed to the fact that the grout was not able to displace the soil present in the cavities. It was decided to abandon plans to proceed with additional grouting. The grout pipes which had been in place were relied on to act as "needle piles" to help transfer the foundation load below the cavities into the competent bedrock below. The structure has not experienced any settlement since it was constructed several years ago. Hence, it may be concluded the limited benefit of the grouting program together with the beneficial support of the "needle piles" was effective in solving the problem presented by the cavities at this site. However, without the additional data obtained by post-grouting percussion probes, the need to incorporate the "needle piles" into the foundation would not have been known and the structure would probably have been subjected to unacceptable and perhaps objectionable movements.

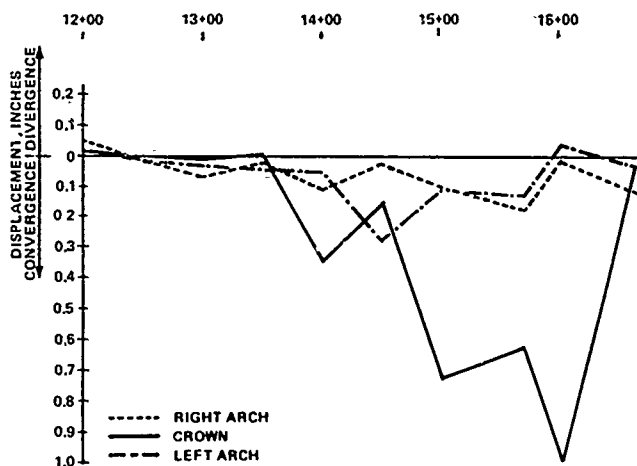
TOTAL DEFORMATIONS MEASURED AT 15 FOOT DEEP EXTENSOMETERS

As shown in the figures, the movements recorded at instrumented stations in the shale were some of the largest observed anywhere along the tunnel. At station 16+00 the total movement in the crown was slightly over 25 mm (1.0-in). Approximately one half of this movement occurred during the excavation of the top heading. As the bench was excavated past station 16+00, the movements were again triggered and convergence proceeded at an undesirable rate. Station 16+00 was located at the interface between the shale and siltstone. When excavated, this area was very blocky and wet. The data indicated that significant movements took place at depths greater than 1.5 m (5-ft) from the excavated surface and possibly deeper than 4.6 m (15-ft). These movements were probably the result of loosening and moving of rock blocks, especially in the crown area. This movement may have been partially driven by water pressure in the rock. Nine meter (30-ft.) long tensioned rock bolts were installed in the converging area, and were successful in stabilizing it.

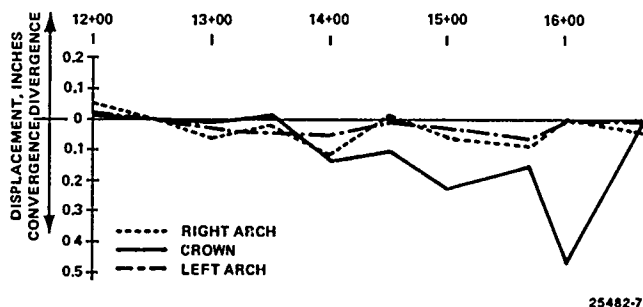
DEFORMATIONS MEASURED AT 15 FOOT DEEP EXTENSOMETERS AFTER BENCH EXCAVATION

In general, the springline instruments showed that very little movement took place as the bench was excavated. Measurements of convergence that were recorded were determined to be the result of loosening of very near surface rock slabs or shotcrete.

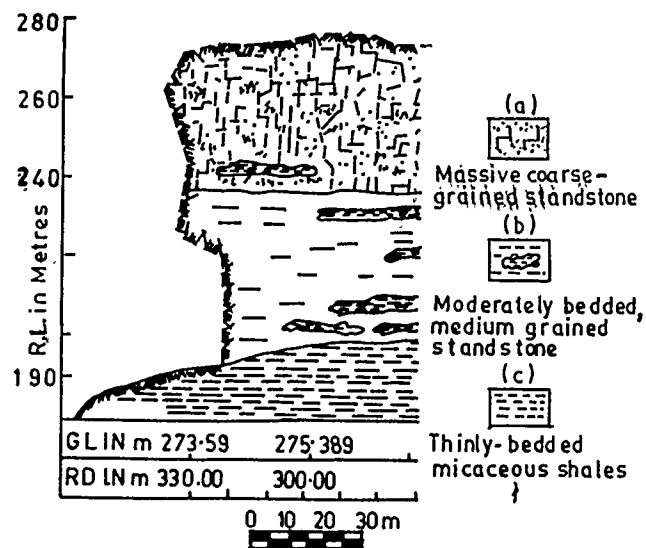
Fig.2 Geological Section of Escarpment

b) Moderately bedded, medium grained sandstone with flat beddings and lenticular intercalations
